FATIGUE TESTING  
OF  
70-30 COPPER-NICKEL

# United States Naval Postgraduate School

## THESIS

MASTER OF SCIENCE IN MECHANICAL ENGINEERING

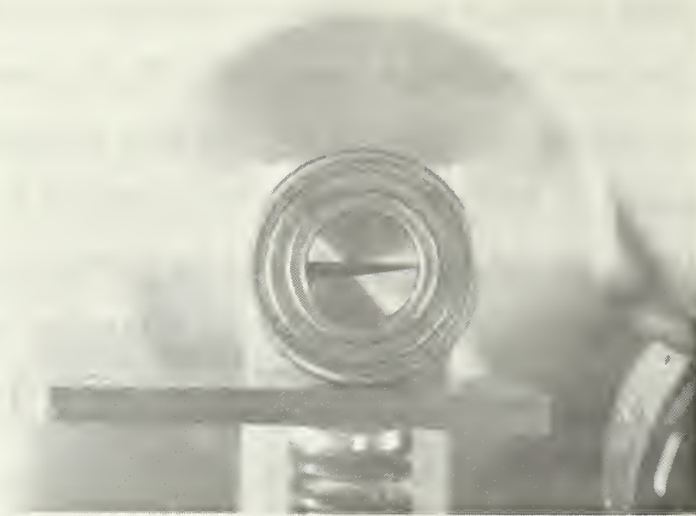
FIGURE 2. ARROW ON CAM IN NEUTRAL POSITION

position for all measurements was obtained by inserting an Allen wrench in the hole in the cylindrical surface of the flywheel and allowing it to bear against the underside of the belt damper plate. This is roughly indicated by the orientation of an arrow mark on the cam as shown in Figure 2.

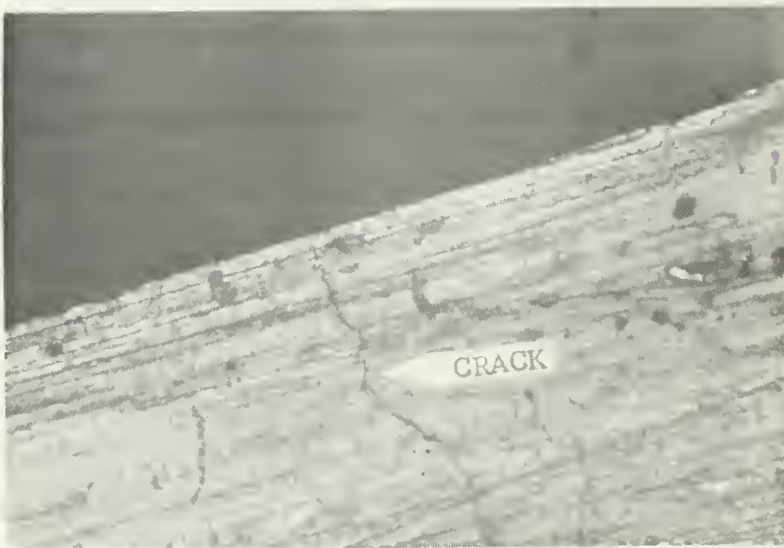
FIGURE 3. FIRST CRACK, SPECIMEN #4, 150X

Inspection of the specimen surface for cracks is a procedure which has to be conducted meticulously and without regard to time. A crack which might appear under one particular light angle often did not appear under another angle. By maneuvering the lamp to different positions and carefully examining the specimen surface under each lamp position, chances of crack detection are improved. Figures 2 through 9 inclusive, illustrate some of the cracks actually detected on individual specimens.

In taking these photographs through the metallograph, the Solder Stop coating was left intact in an attempt to illustrate how this coating accentuates the cracks. With a crack detected, the resistance change at that number of cycles was recorded and the test terminated.

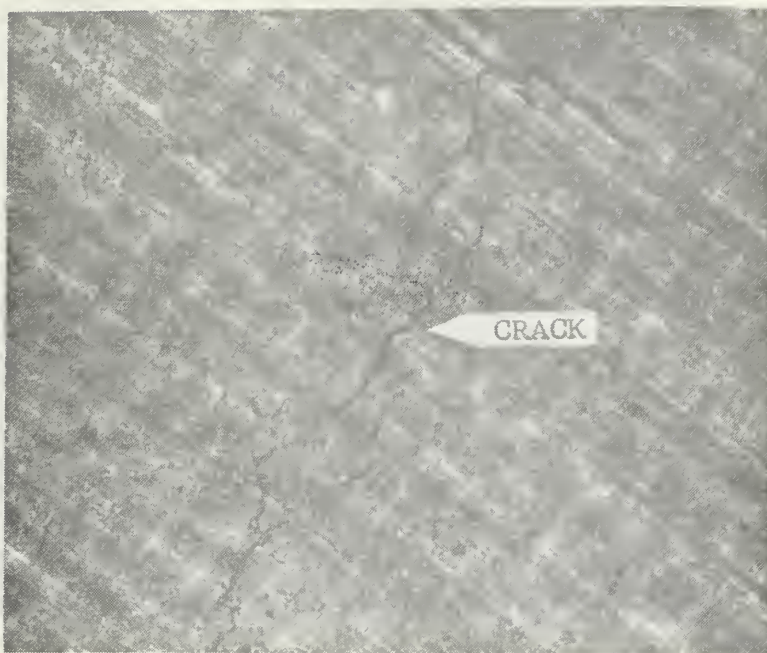
FIGURE 4. FIRST CRACK, SPECIMEN #6, 150X

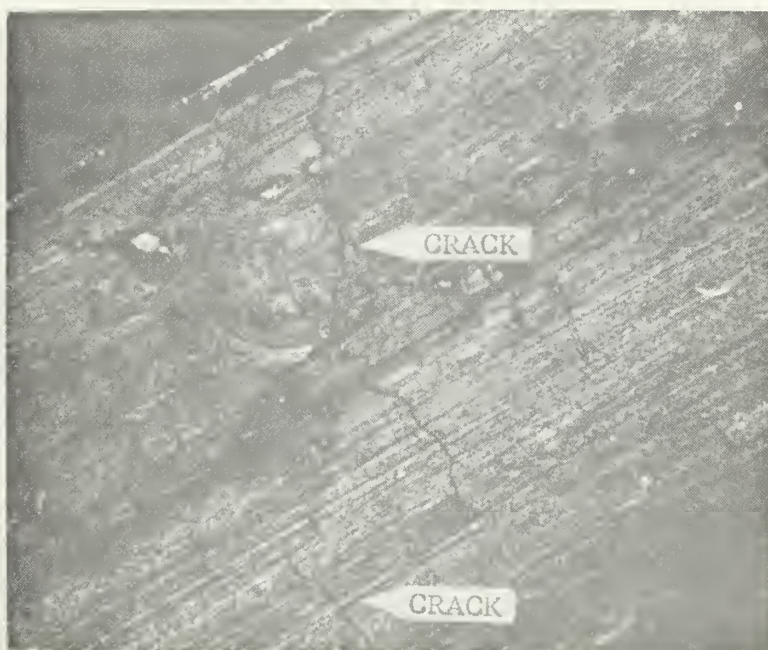
FIGURE 5. FIRST CRACK, SPECIMEN #8, 100X

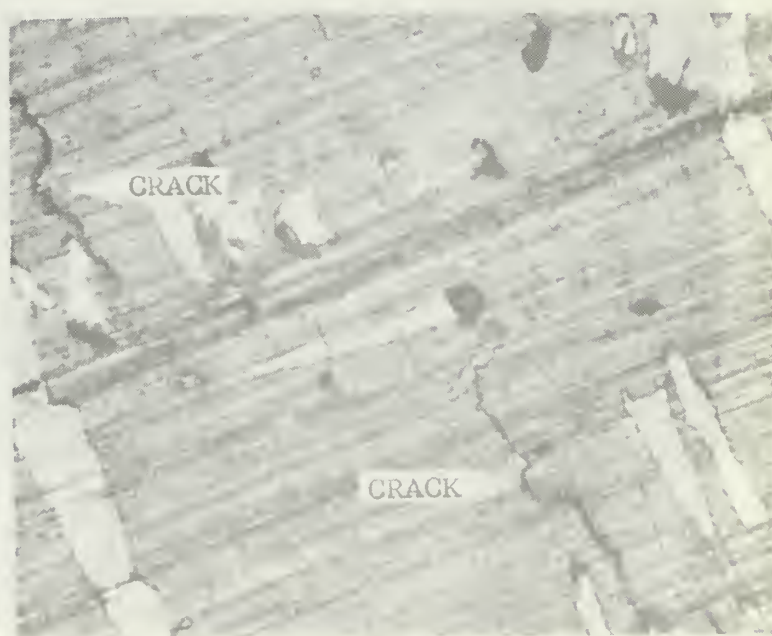
FIGURE 7. SECONDARY CRACKS, SPECIMEN #7, 150X
